CHAPTER SIX

NATURALISING WAIWHETŪ STREAM CONCRETE CHANNEL, NAENAE

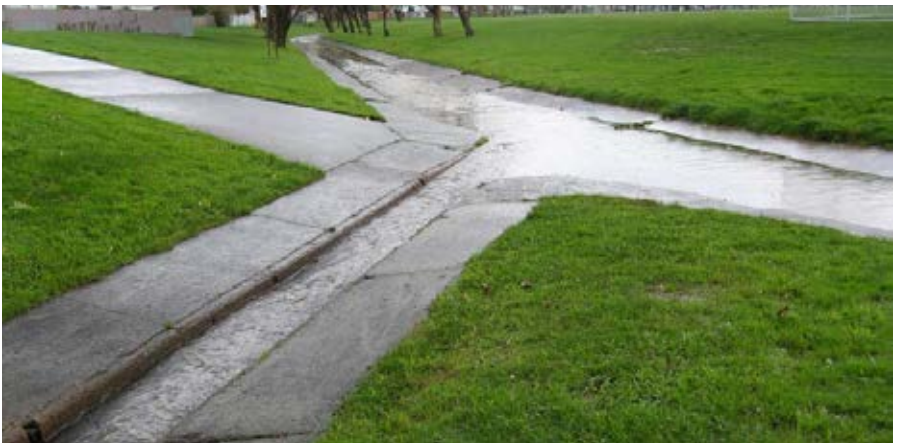
Fig. 1 Concrete channel confluence, Naenae Park

In Naenae there is approximately 2.3 km of channelised Waiwhetū Stream as well as smaller side channels (Fig.1) from Rata Street to Waddington Drive ext. Hutt City Council (HCC) and Wellington Water (WW) are responsible for this section of the stream.

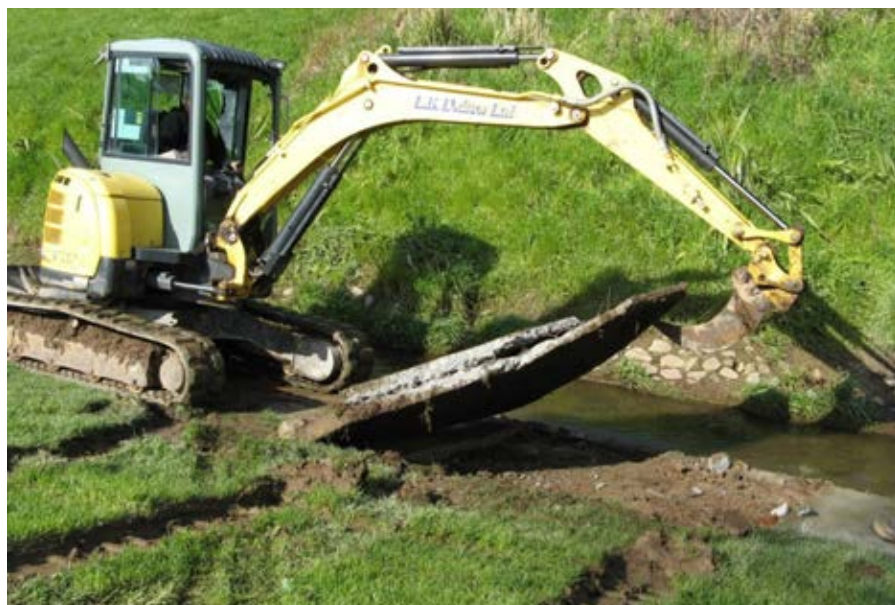
Fig. 2 Digger removing concrete berm

In 2015, in an effort to improve inanga upstream migration and naturalise the channel, Craig Cottrill (HCC) supported a FWS initiative that involved removing two separate sections of the 2 m wide concrete berms along the lower 50 m of the channel (Fig. 2). The trial included placing large and mixed rocks into the channel itself and FWS volunteers planting the areas that had been under concrete. The naturalisation potential of the initiative was supported by Diana Isaac and Iqbal Idris, Senior Engineers (WW), who wanted to contribute by removing another section of berm further upstream; the latter was achieved in 2016 with planting and 'rock rolling' (into the channel) done by WW volunteers.

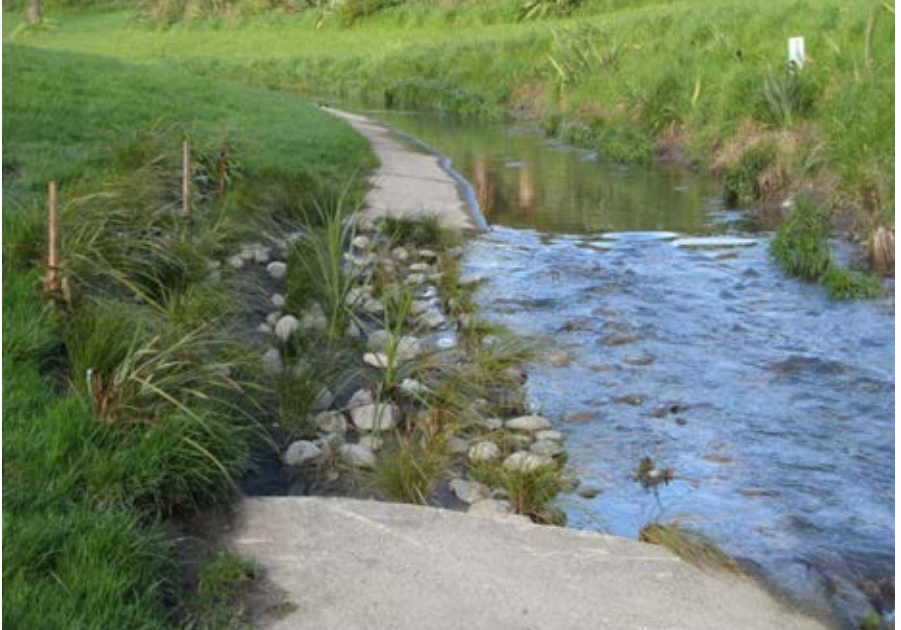
Fig. 3 Planted area and showing riffle created after placing rocks in concrete channel, Naenae

The presence of large cobbles (or roughness) in the base of the concrete channel creates a form of riffle which slows the flow velocity down and creates a backwater effect upstream under normal flow conditions (Fig. 3) and velocity is reduced enough for inanga to be able to swim upstream (which has been observed).

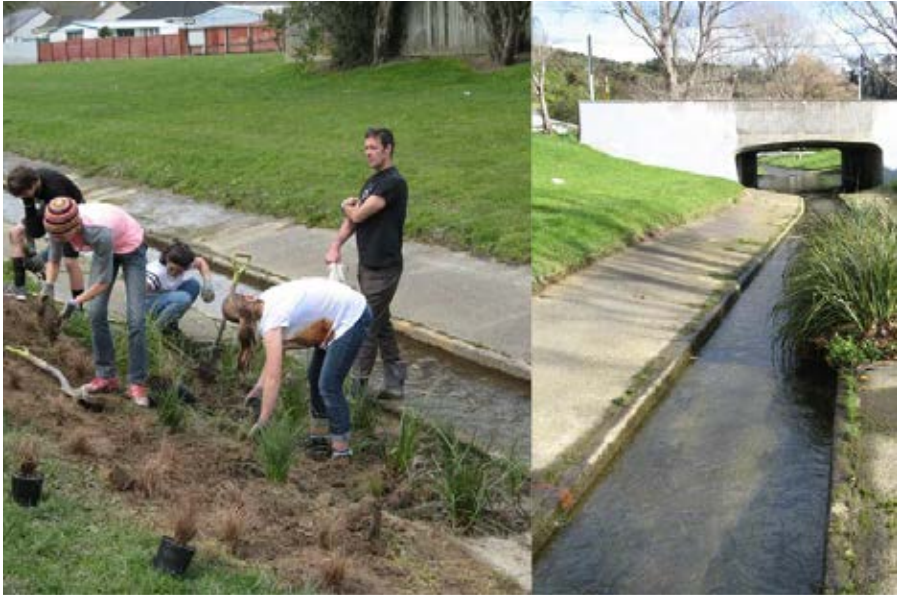
Fig. 4 Wā Ora Montessori School students planting in 2016 and result

It was noticed that a length of concrete berm was missing on one side of the channel, just upstream from Waddington Drive, so in 2016 a planting was arranged for a small group of students from Wā Ora Montessori School (Fig. 4) and the softening effect of draping native *Carex* is evident after three years growth.

This naturalisation initiative has largely been successful; the most obvious change has been the creation of the ‘babbling brook’ sound of water passing over and through rocks compared with the silence of water in a concrete channel. Some plants have suffered because during heavy rain events they have been impacted by fast flows coming down the channel from upstream as well as detritus and domestic rubbish.

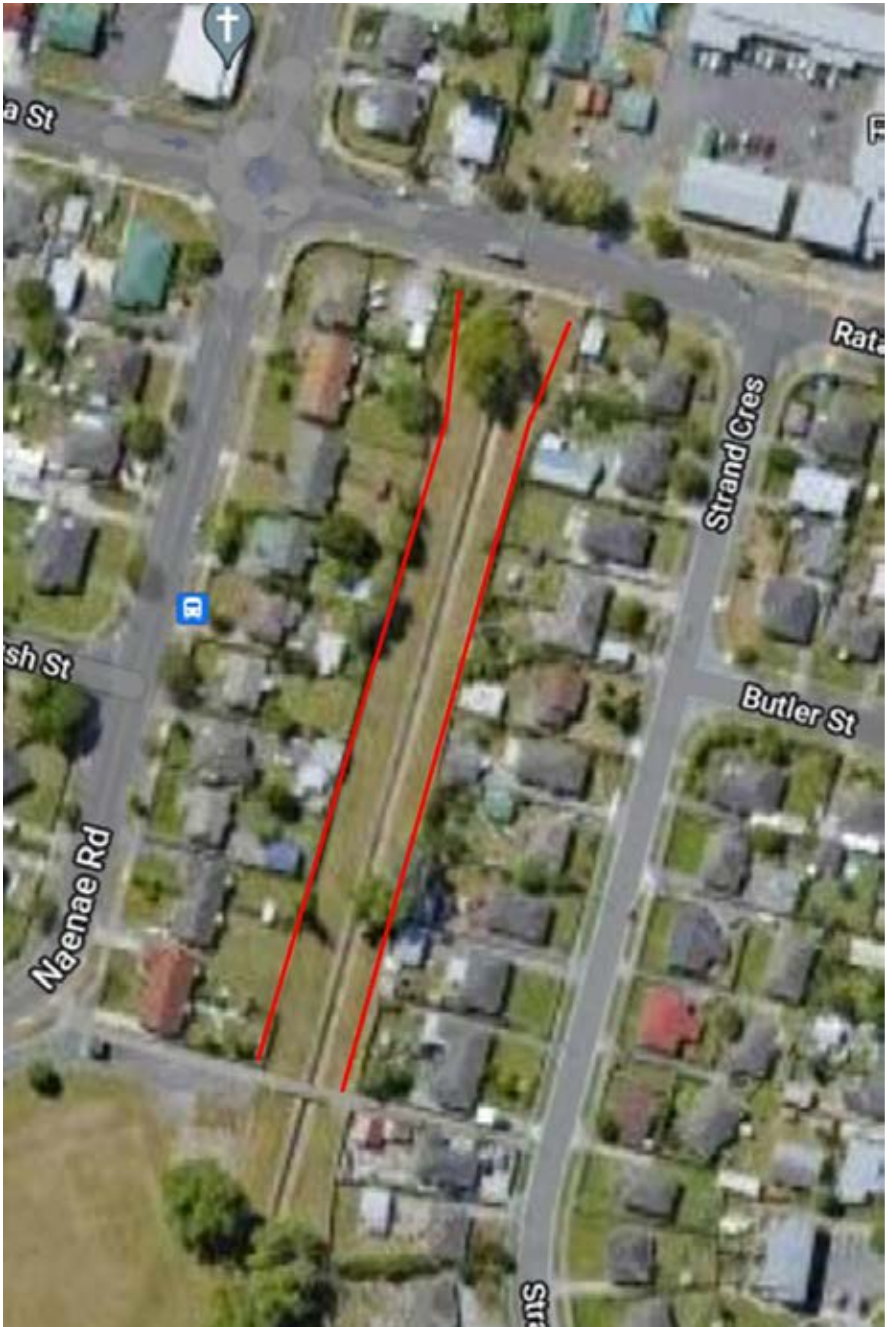
Fig. 5 Aerial map of naturalisation area, Naenae with the red lines

Subsequently, a planting/naturalisation concept was formulated and a proposal for HCC to consider was produced. The concept included naturalising the concrete channel between Rata Street and a footbridge at the north end of Naenae Park (Fig. 5) with the use of rock mini-weirs across the channel to slow water flow and also create pooling behind the weirs. The proposal included planting a 1.5m width along the sides of the concrete berms and with *Carex* spp. closest to the edge of the concrete; these would drape over the edge and disguise the concrete. In addition, it was proposed that a walk/cycle path be

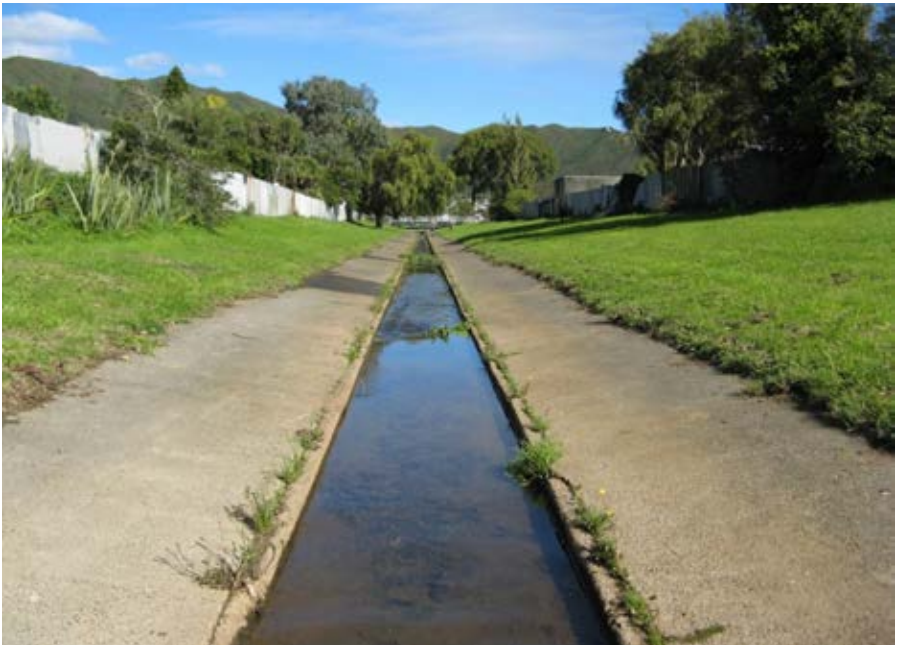
Fig. 7 Barren and ugly before planting and naturalisation

Naturally transported gravels have filled the channel itself, disguising the concrete and providing a natural substrate. One of the main issues has been that the rocks delivered for the mini-weirs were not large enough; some have been buried under gravels, and some removed illegally (B. Elks pers. comm.). However, there is a vast improvement in the aesthetics of this section of stream; from barren and ugly (Fig. 7) to vegetated and pleasing (Fig. 8, 9) and with access to Naenae Park from Rata Street.

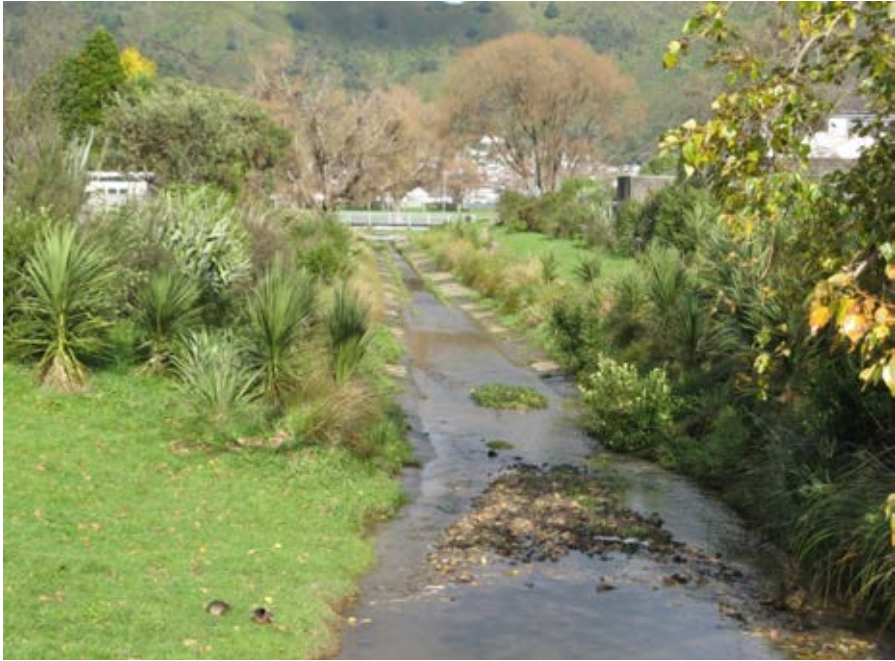
Fig. 8 Naturalisation progress 2022

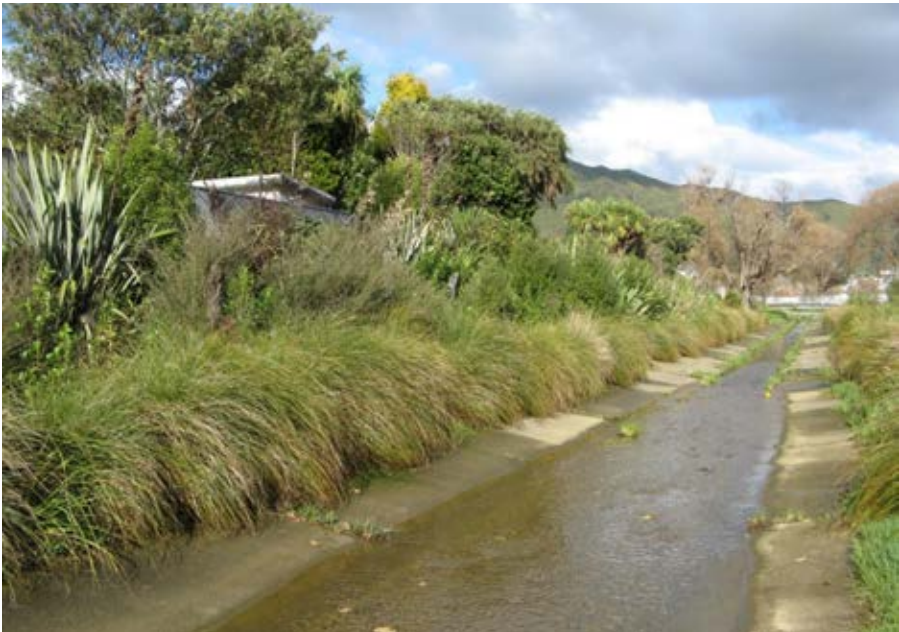
Fig. 9 Carex secta draping over edge of concrete berm and taller plantings at the back
